Your Inspection Report

2844 Connie Dr Unit A & B
Sacramento, CA, 95815

INSPECTION DATE:
August 13th 2021

Report No. 022

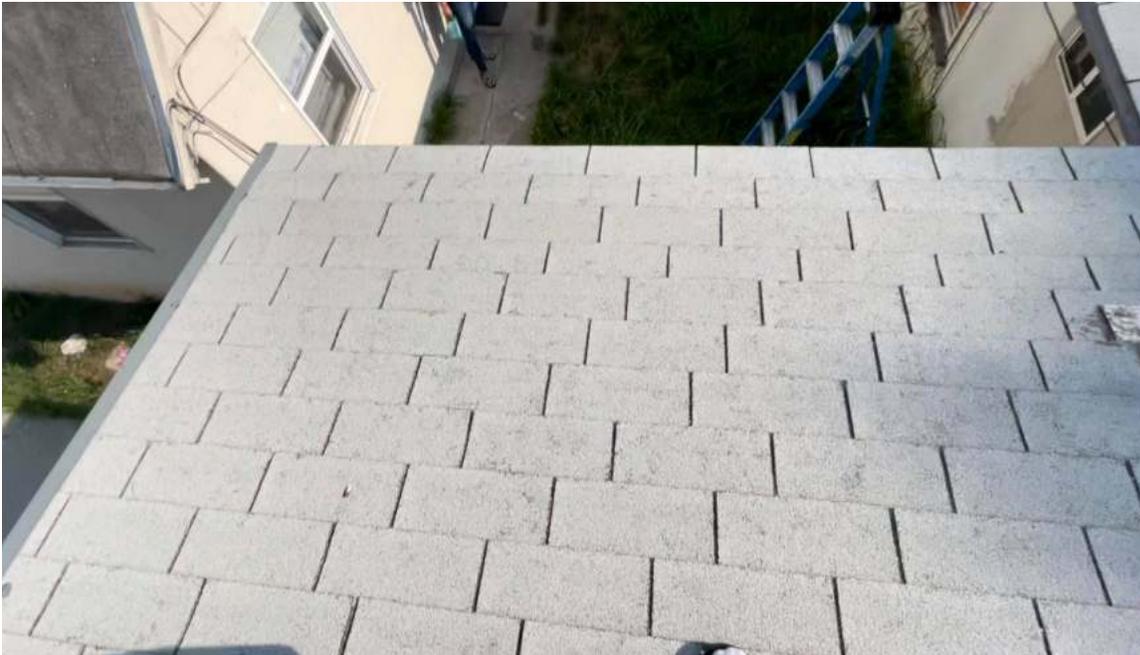
Condition: • 3 Soft areas on top of unit A. Walked on roof

Task: Additional evaluation or inspection by a licensed roofing contractor

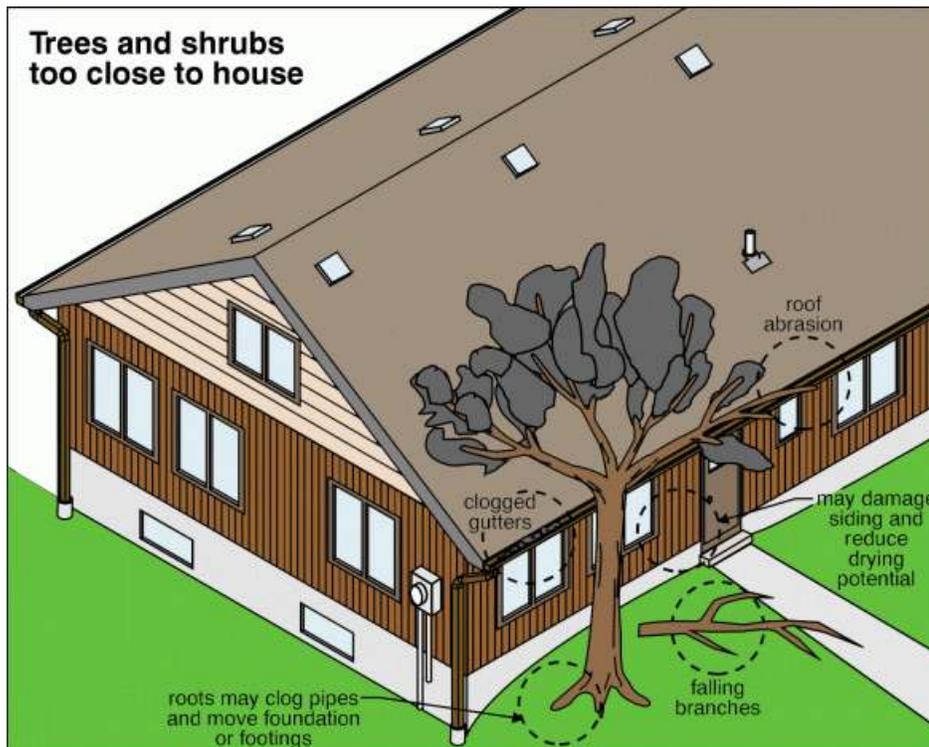
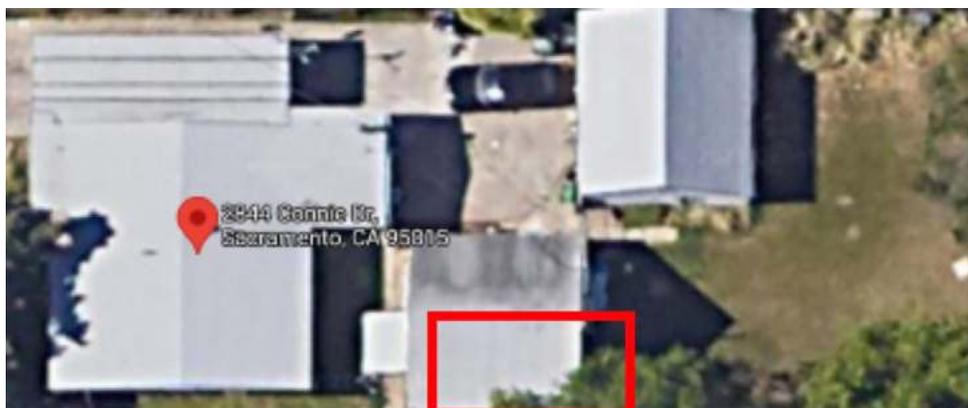
Condition: Tree branches touching roof
Tree branches touching and debris on roof.

Removal of tree branches from unit B

Task: Correct

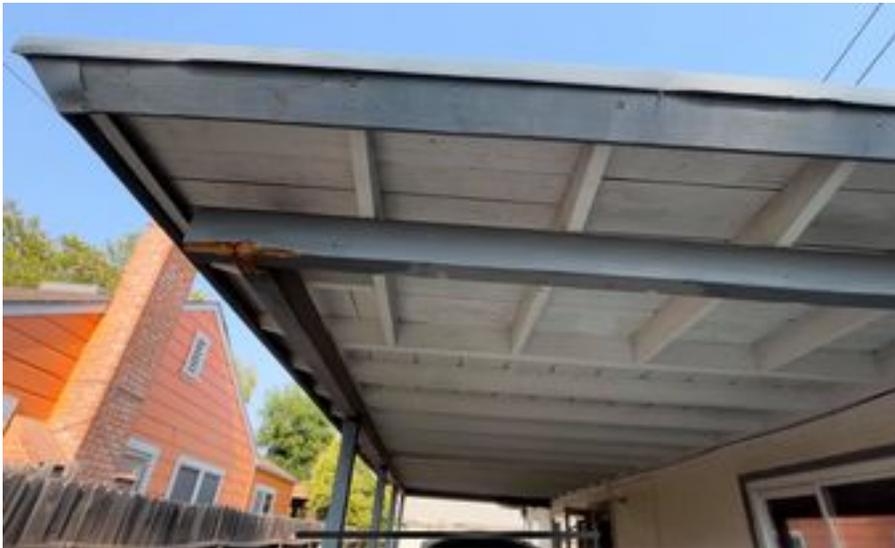
Condition: Damaged structural lumber

Task: Correct

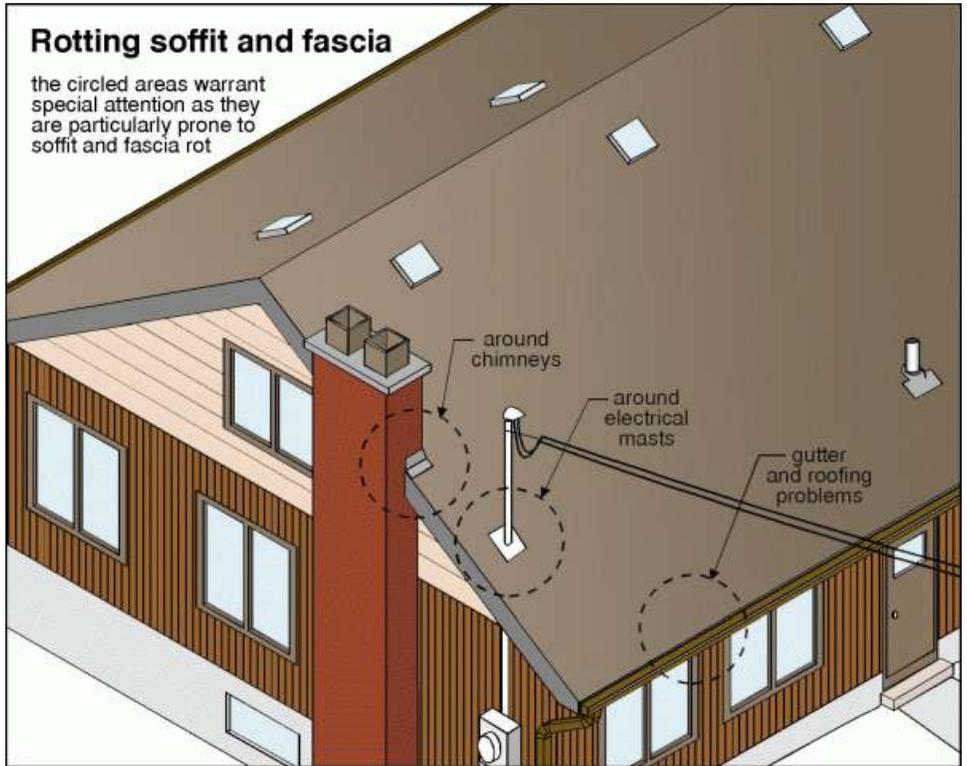
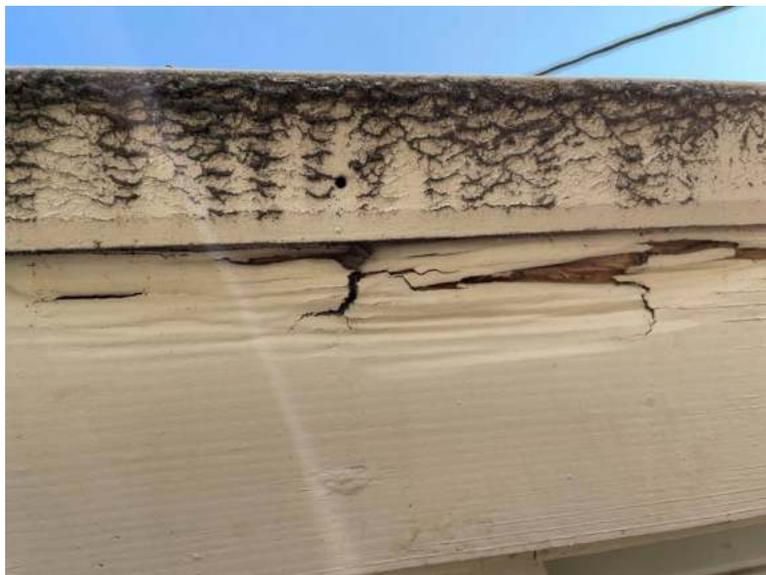
Condition: Damaged fascia

Fascia damage

Task: Obtain estimate for repairs or replacement

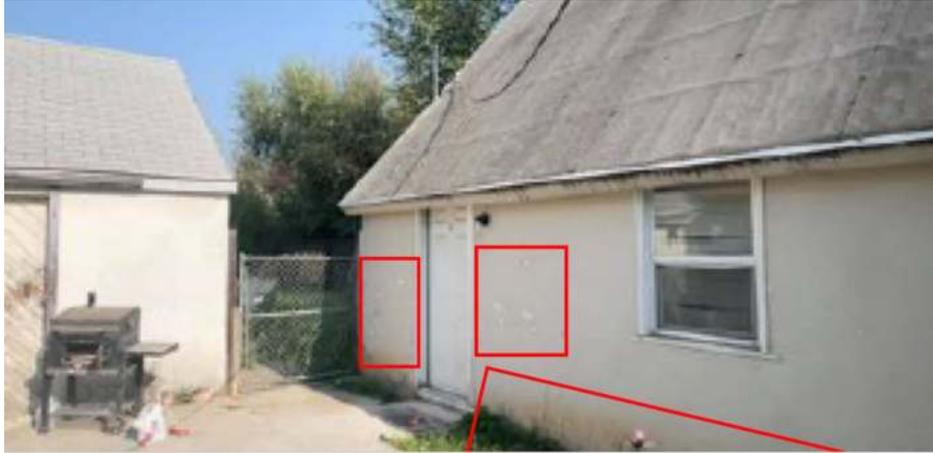
Condition:Damaged Stucco

Location: Left side of unit B. Stucco chipping.

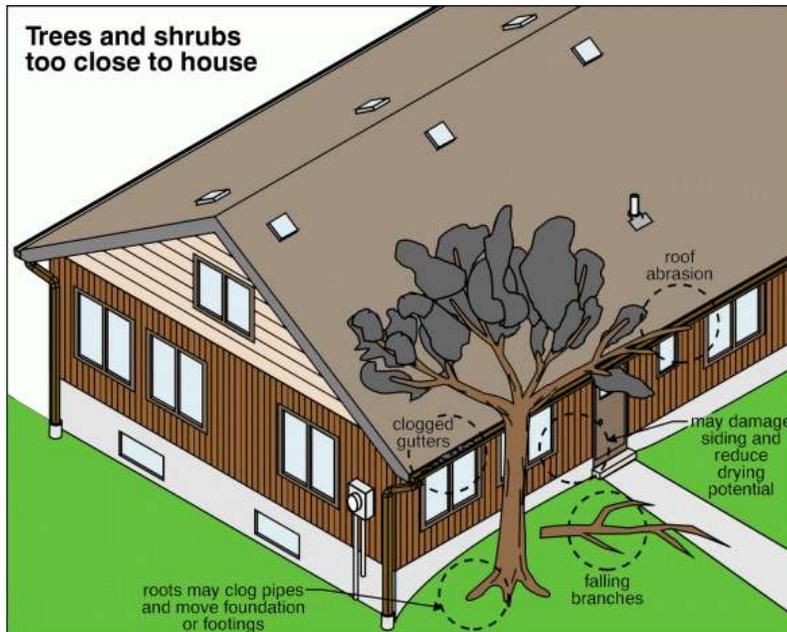
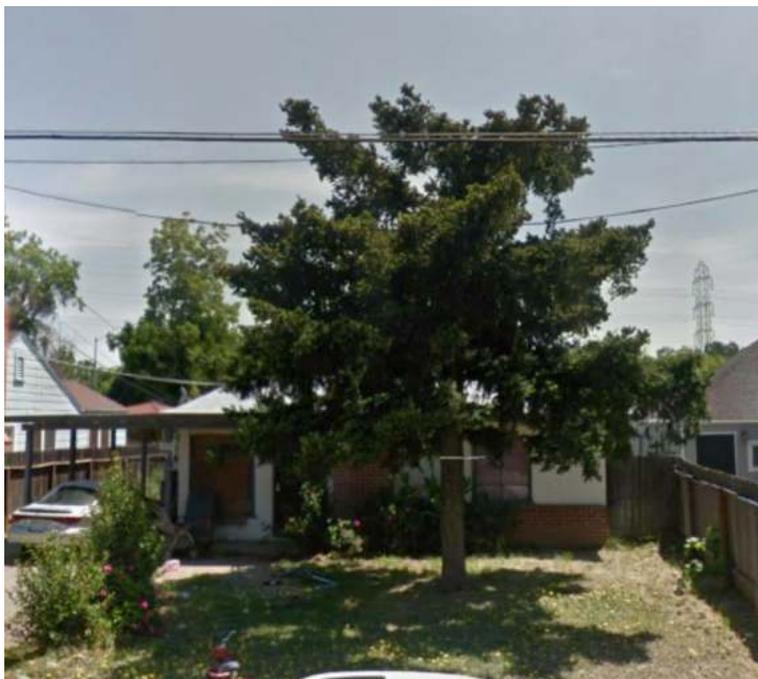
Condition: Trees or shrubs too close to building

Damaged tree in front yard

Task: Remove

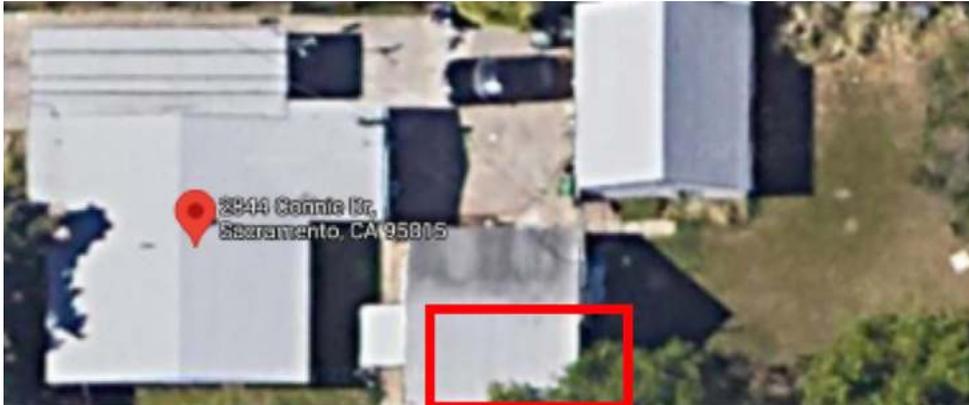
Unit B tree shrub in contact with roof

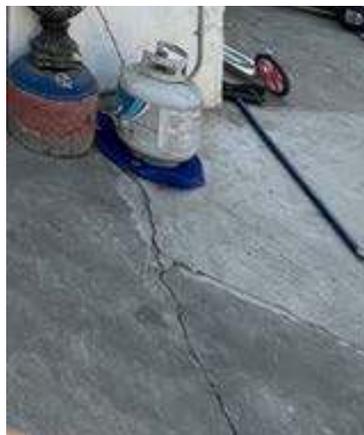
Condition: Cracks were noted in the driveway caused by settlement, normal use, age or erosion of the soils below. Recommend sealing the cracks per industry standards and/or obtaining an estimate from a licensed contractor for repair or replacement of the driveway as needed. Estimate(s) for repairs should be acquired before the purchase of the residence.

Task: Obtain estimate for repairs or replacements

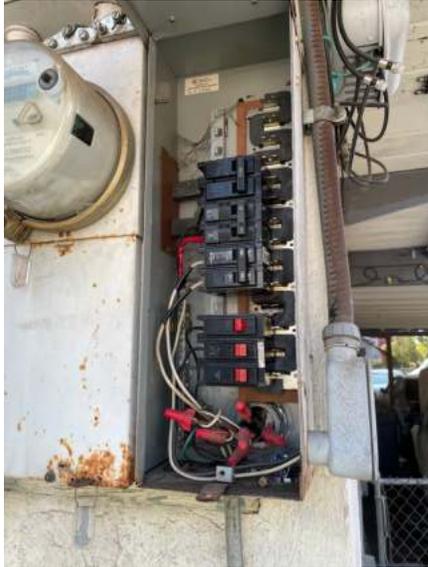
*Slot 10 burned due to overheating damage

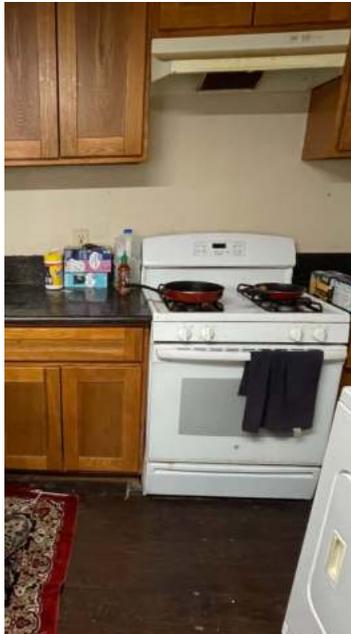
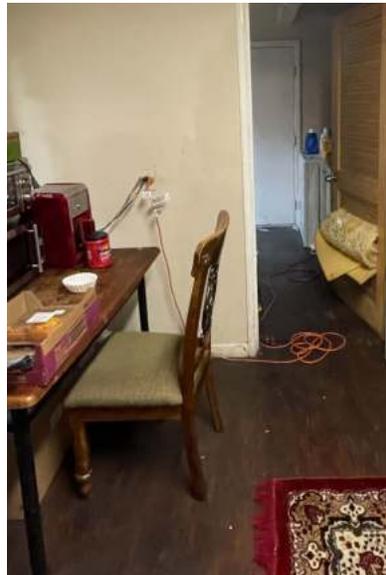
Oven range/hood exhaust inoperable, including all outlets in kitchen, dining room, washroom, except for a single outlet

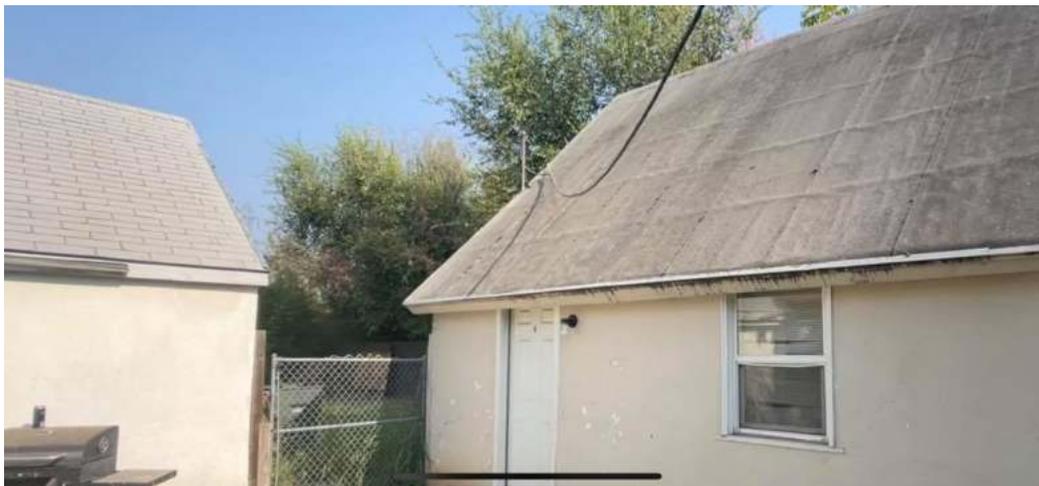
Condition: Degraded

Replace service conductors for unit B

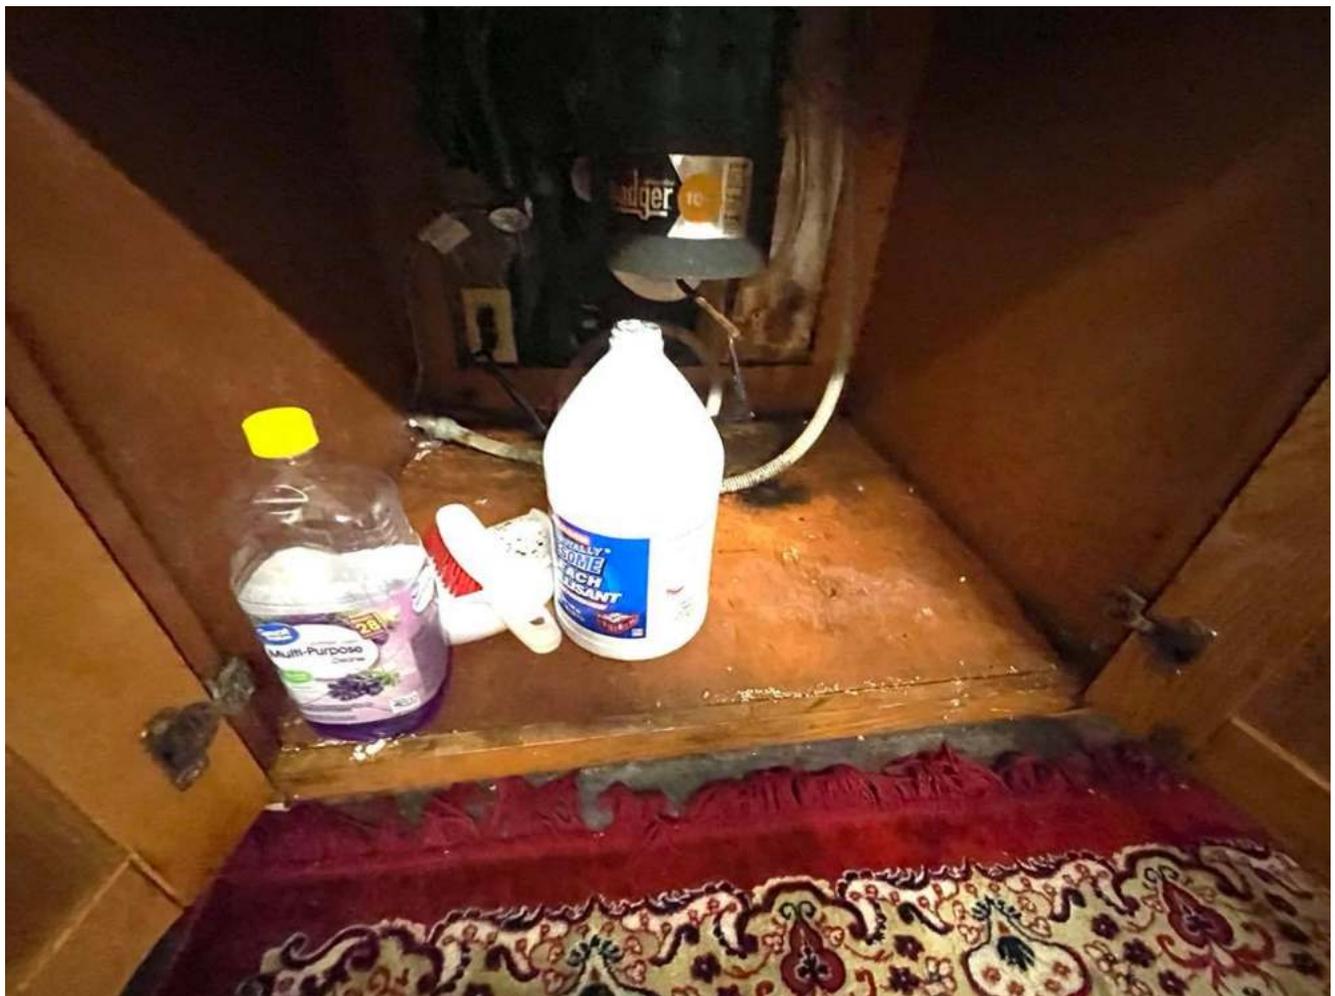
Wall underneath kitchen sink has deteriorated, water is constantly dripping in unit A due to water backup. The adjacent wall is damaged in addition, in same local area.

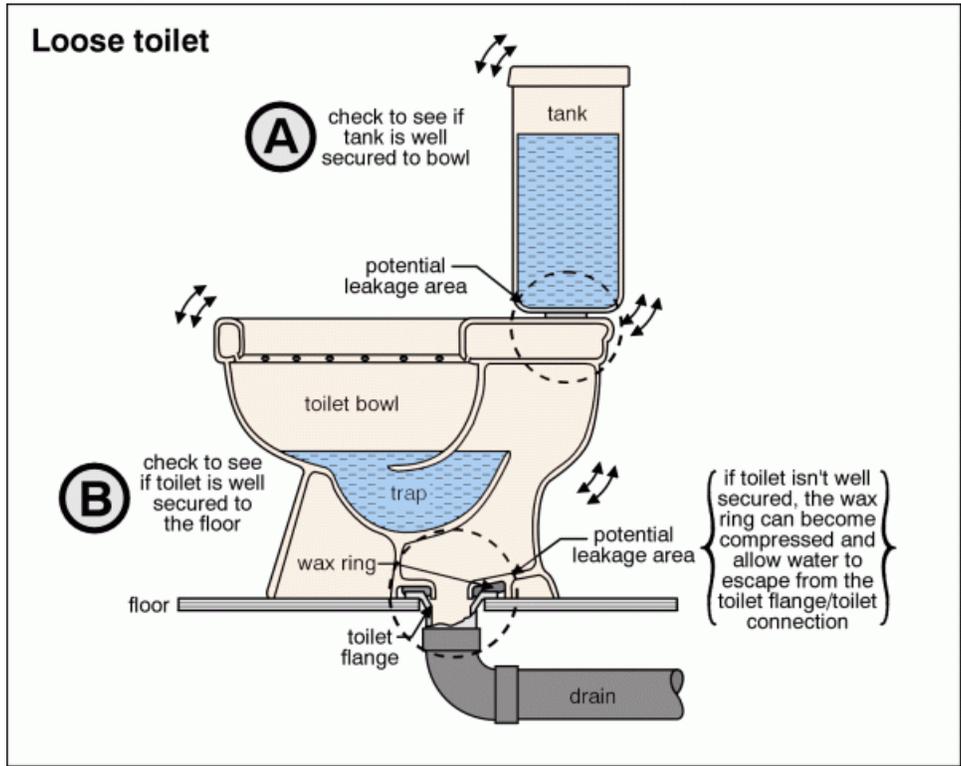
Loose toilet

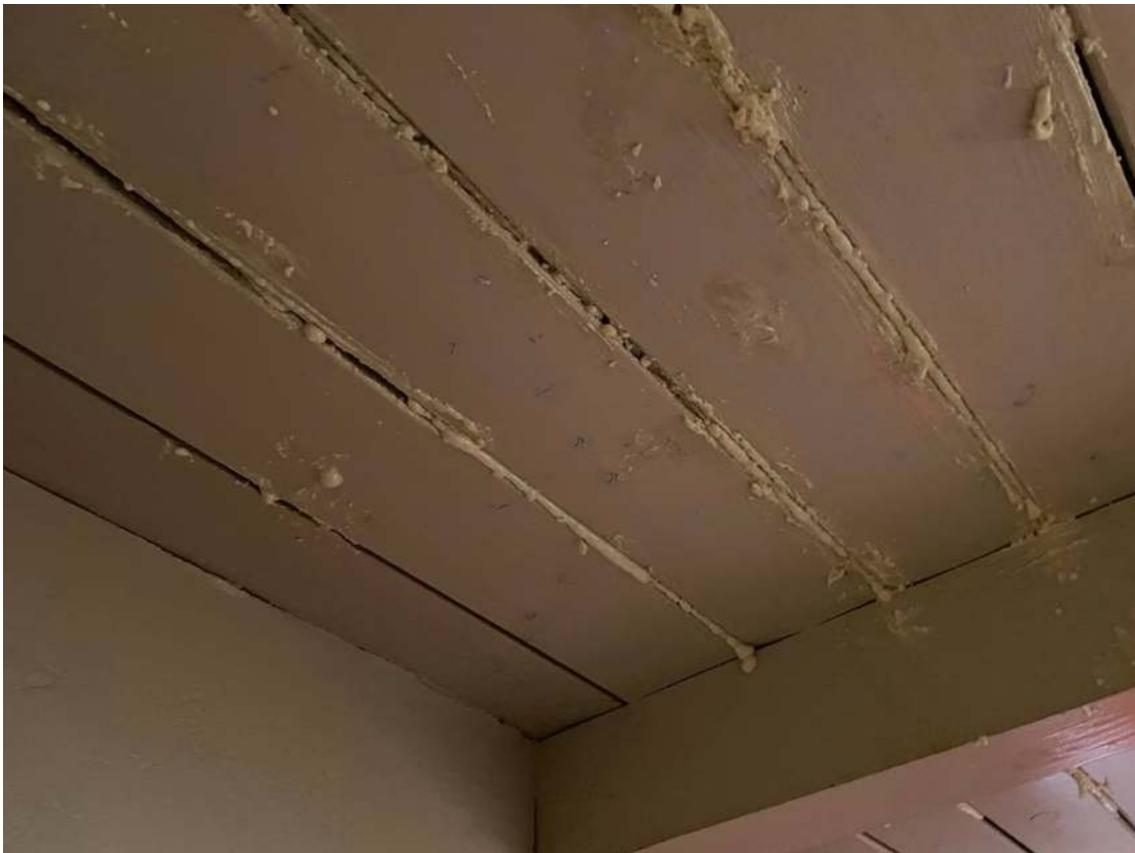
Ceiling damage - Unit A Bedroom

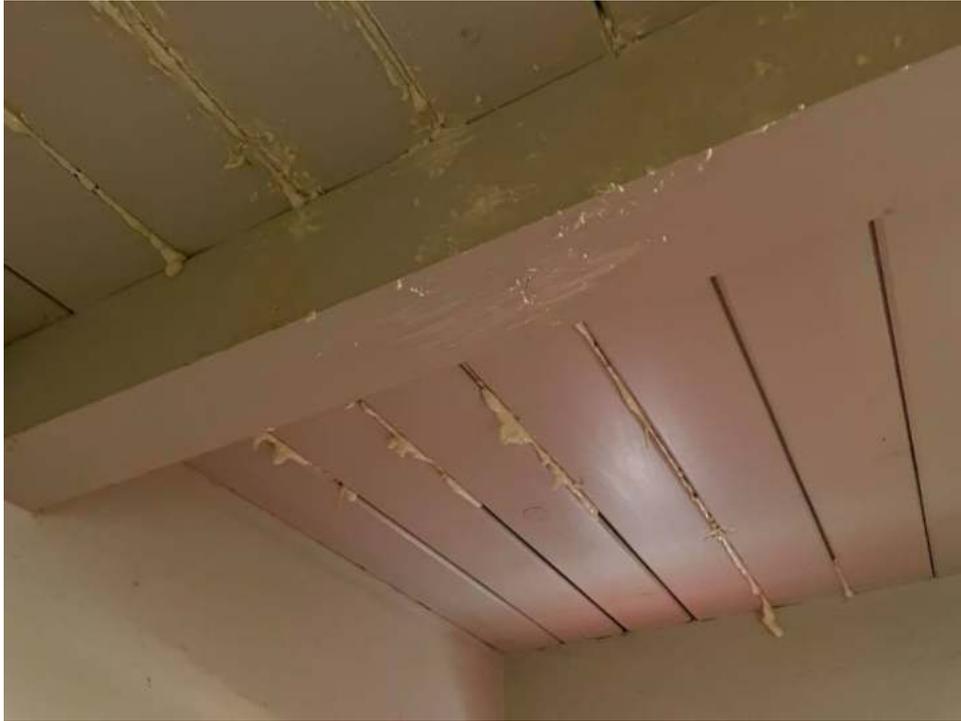
Ceiling damage - Unit A Bedroom

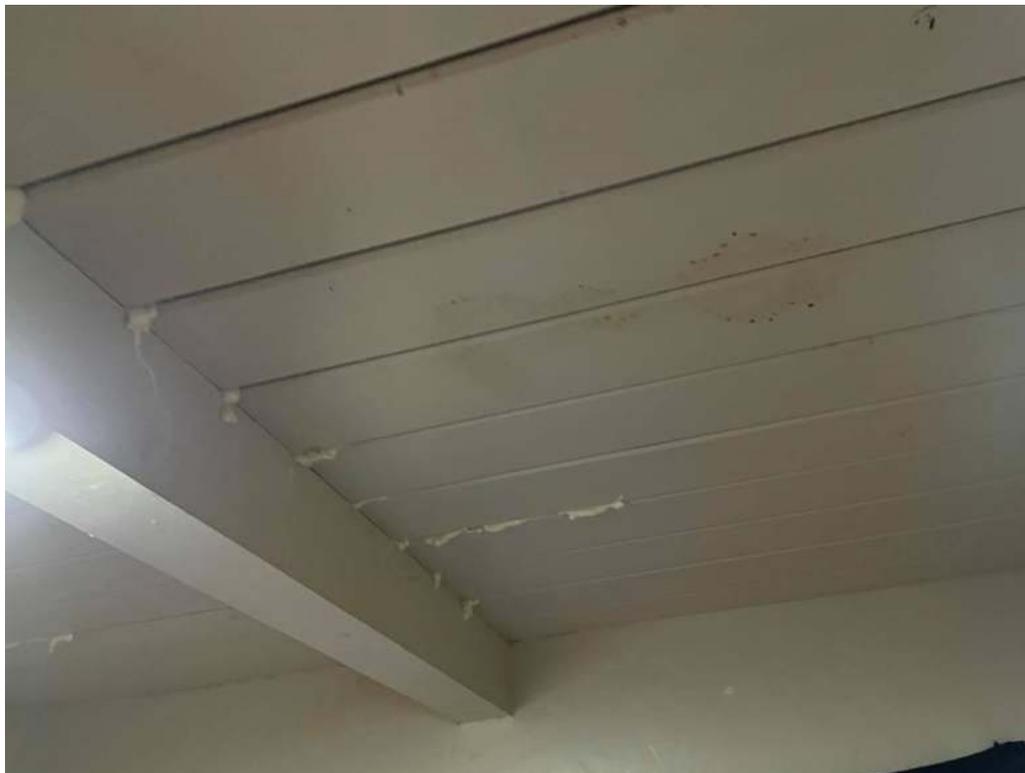
Ceiling water damage - Unit A Bedroom

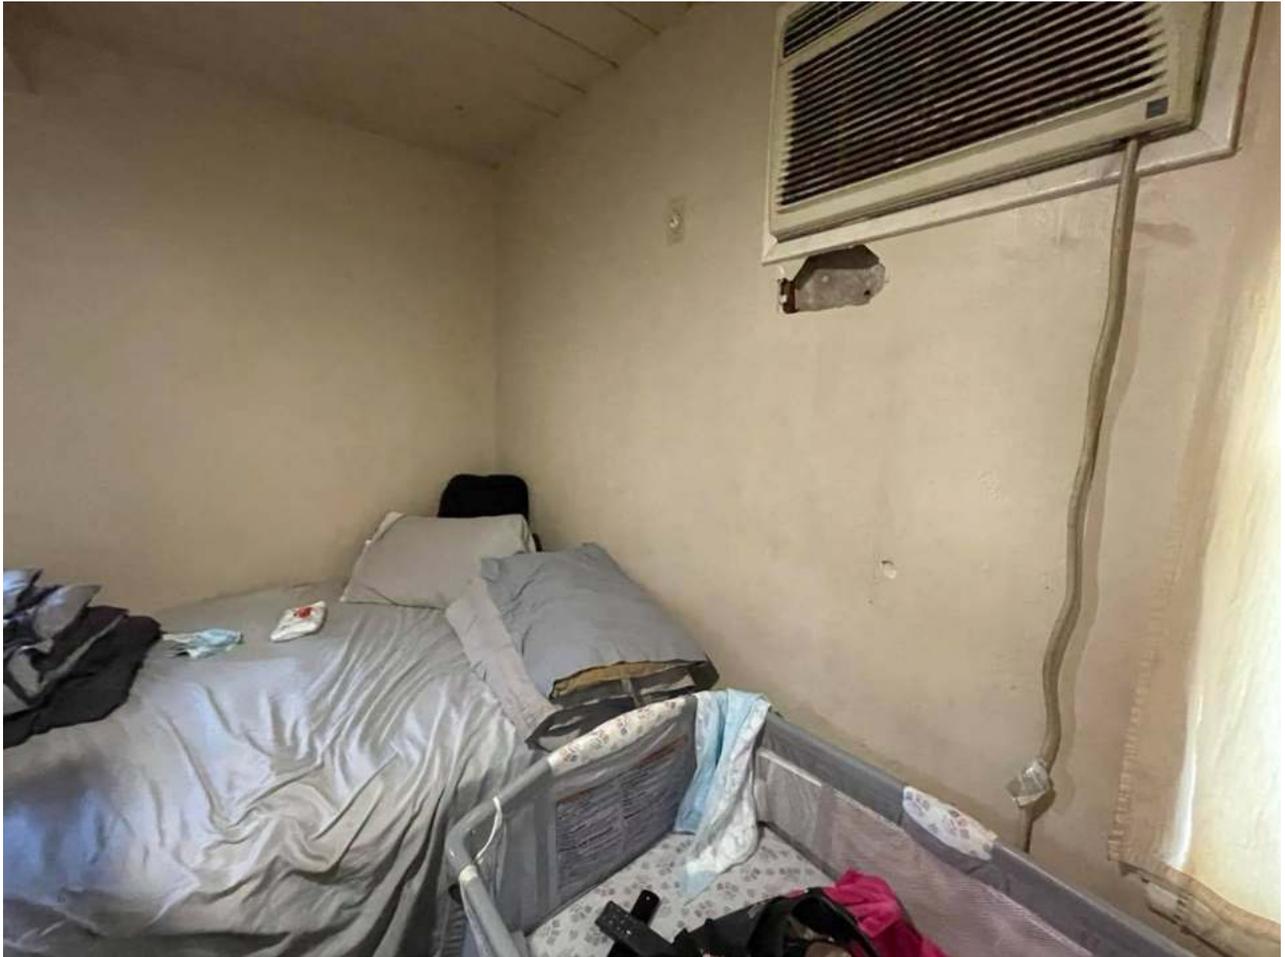
Inoperable A/C unit, Improperly sealed, & Drywall damage

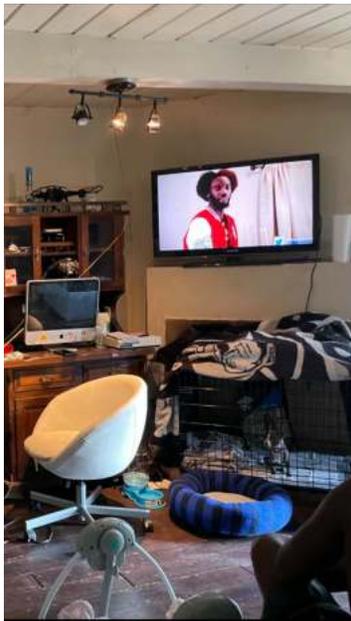
Fireplace insert inaccessible, located below TV

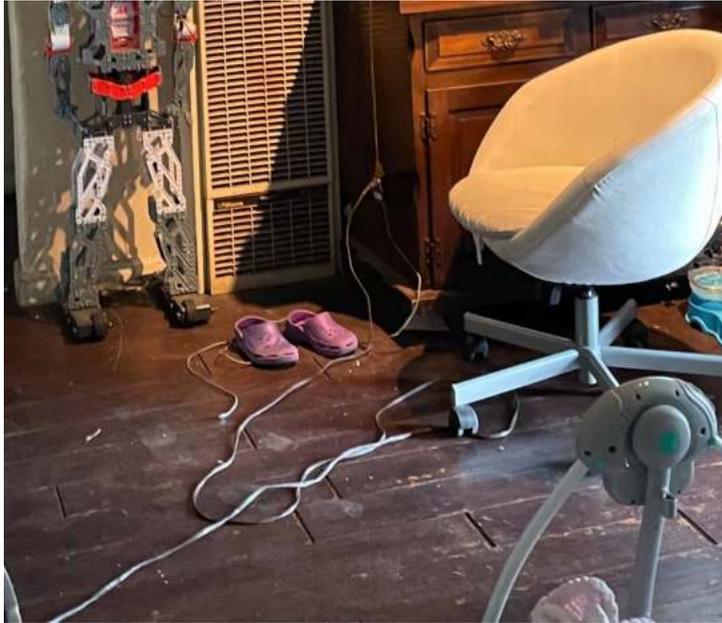
Floors are in need of replacement

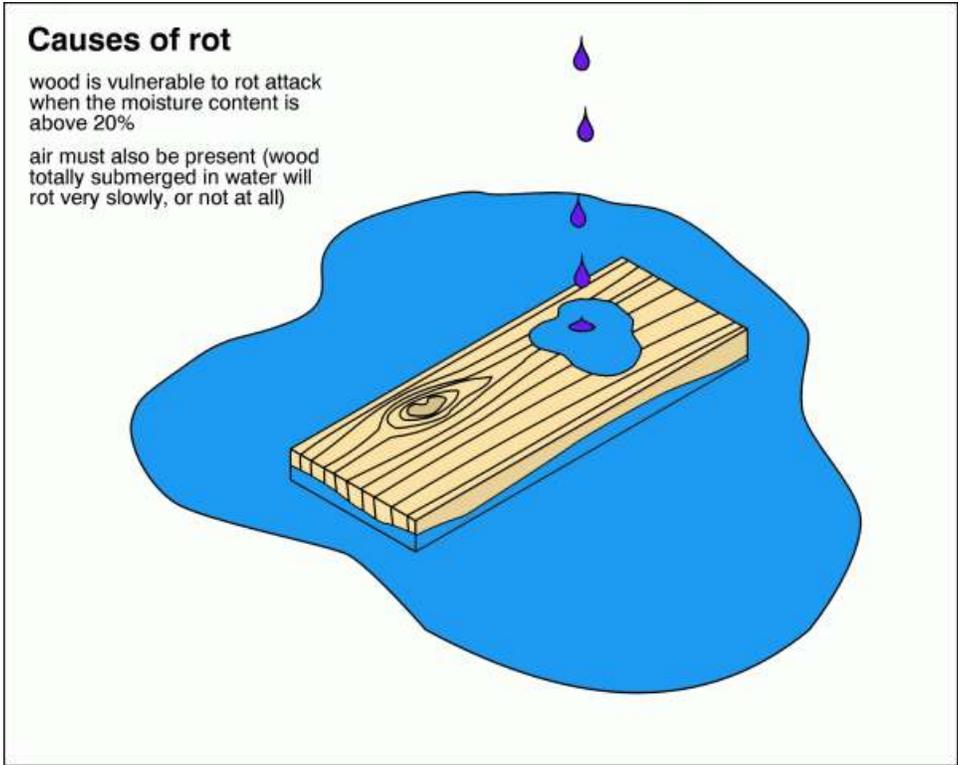
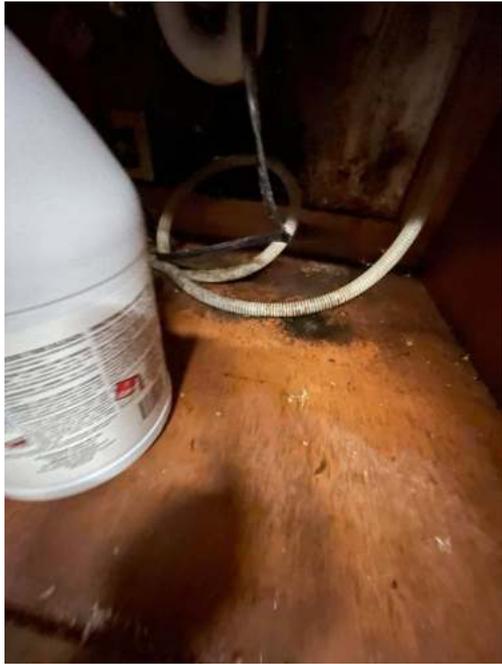
Water damage - Unit A Bedroom
